The conservation and repair of the Calvary Cross **Will you support us?**

St John the Baptist,
Holland Road

A power point presentation showing the Calvary Cross, and the work needed to make it safe and conserve it for the future.

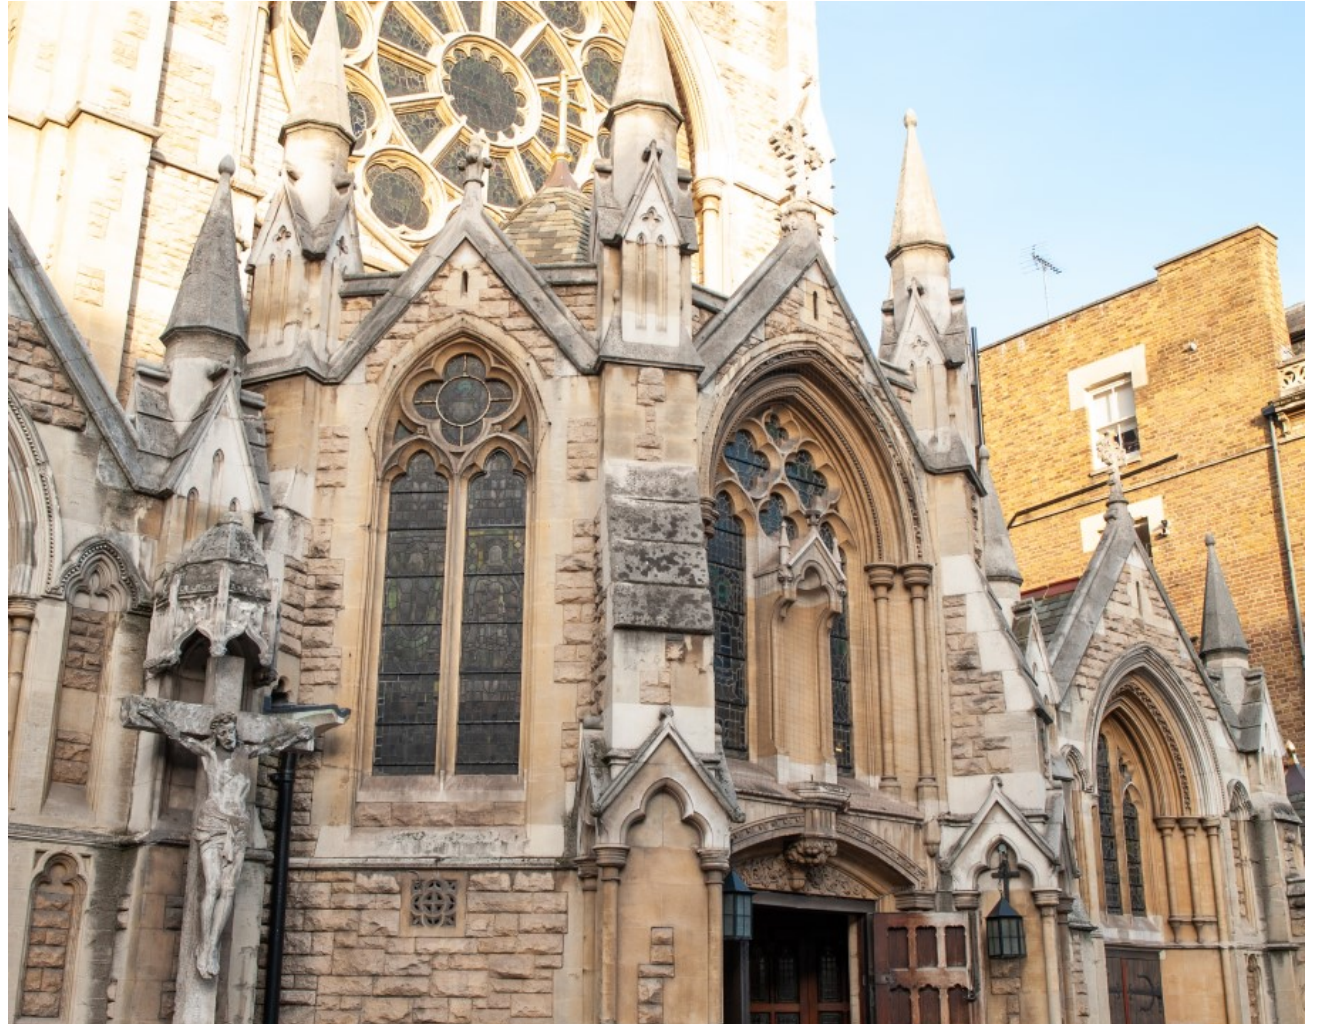
The calvary can here
be seen in situ just to
the north of the main
door of St John's.

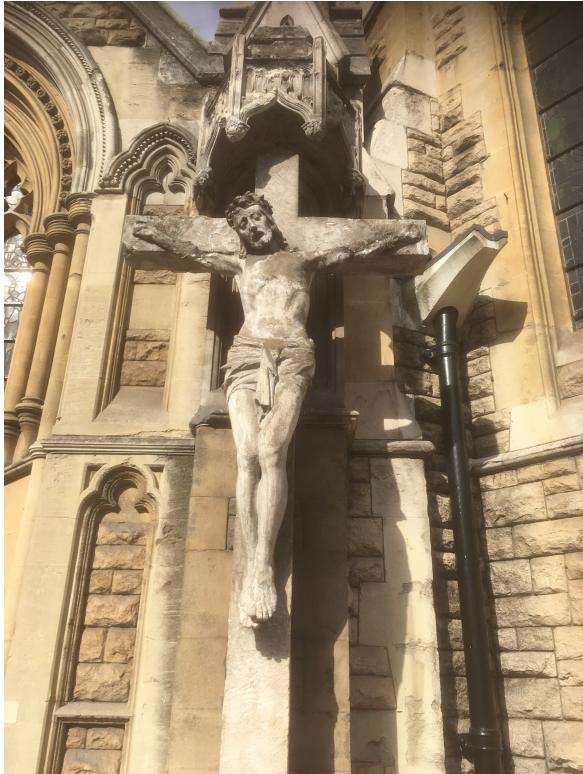
The Calvary

- During lockdown the statue has become an important focus for many, as a tangible place to express their faith. It is now very common for offerings of flowers to be placed beneath the cross. Some people, in addition, touch the statue during their prayers.
- The statue itself has eroded severely due, partly due to air pollution.
- Parts of the statue are held together with chicken wire and we are in danger of losing the integrity of the carving.

- Phase One:
- Construct tower scaffolding around the Calvary and commence cleaning, using a hand held steam cleaner and conservation sponges. Possible use of poultices for specific areas if the steam cleaning is ineffective. Possible use (after spot testing) of the Doff Stone cleaning system if the smaller steam cleaner is ineffective.
- Survey the cleaned Calvary to reassess the damage and decide which areas need mortar repairs.
- Recommended areas for mortar repairs and consolidation are the feet and possibly the crown of thorns if it is deemed stable enough after cleaning. If the crown of thorns is too damaged then it will need to have a carved stone replacement.

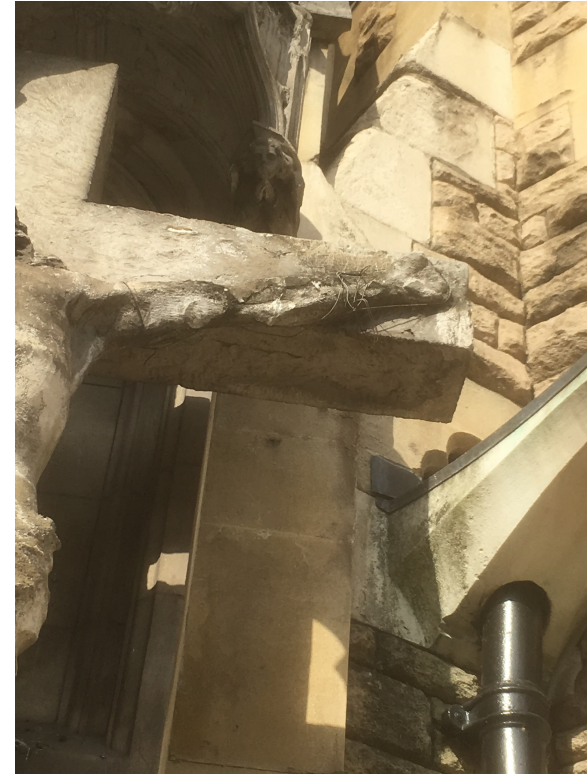
Showing an area of loss including the left hand completely missing

- Produce silicone moulds of the damaged arms and possibly the thorn of crowns. The plaster casts taken from these silicone moulds will form the base of the model for the new carving. This method is employed to maintain a high level of accuracy when it comes to jointing the new stone to the original, as well as keeping the model in proportion with the original figure.
- Produce the model of the arms using the larger wooden version of the Calvary inside the church as a reference for the position of the hands.
- This procedure will be repeated for the crown of thorns if needed.
- Once the models are finished, Portland stone blocks will be order to the correct size.
- Using a pointing machine the models will be copy carved in the Portland stone.

- Once the carving is completed the damaged stone can be cut away and the new stone carvings can be installed.
- Small amounts of in situ trimming in will be needed around the joint between the new stone and the original stone.
- Finally the joints will be pointed
